# Understanding and Quantifying Contaminant Discharges to Haytons Stream

A thesis submitted in partial fulfilment of the requirements for the Degree of  
Master of Science in Environmental Science

University of Canterbury

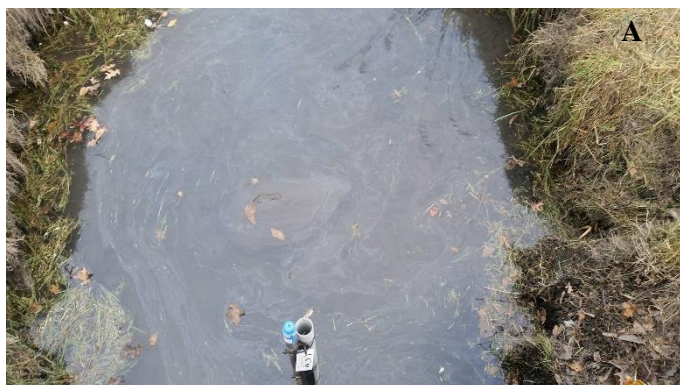
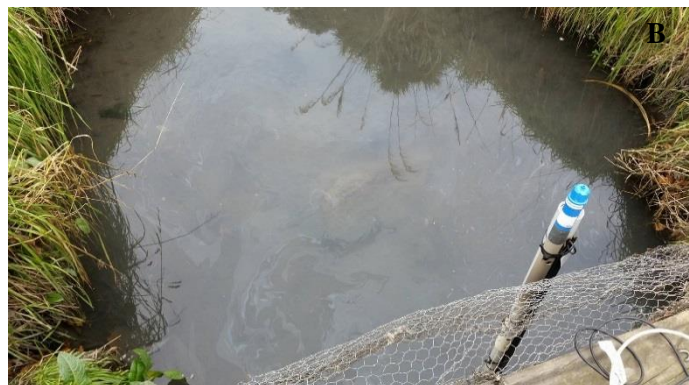
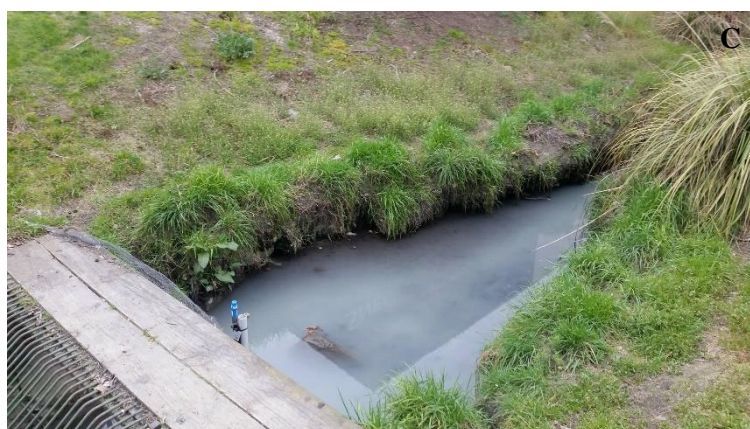
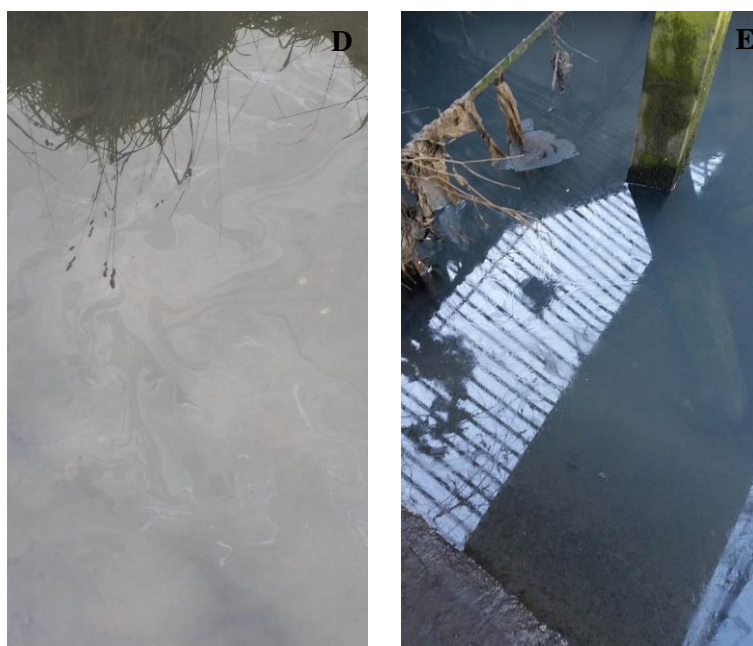
Figure 3.8 Discharges seen at Waterloo Road

The majority of discharges were observed at Waterloo Road, where the stream immediately exits the stormwater network. All discharges at this site were seen exiting the large pipe, which drains the whole upper catchment of industrial Hornby (Figure 3.8). Almost all discharges at this site were hydrocarbon-based slicks exiting from the network, with the exception of a milky-opaque stream colour and yellow organic-looking scum on the pipe steel grating on 30/8/17. At first, PAHs were tested for in the presence of a hydrocarbon slick (such as photograph B). Yet after the first two discharges analysed, total PAH concentrations were low and did not reflect the extent of the sampled discharge, thus TPHs were then tested for to gain an understanding of total hydrocarbon presence/ composition. All are hydrocarbon/oil based, apart from the milky opaque discharge, shown in the photograph in the bottom middle below (photograph C).

On 25/7, a sticky-lubricant looking discharge was observed at WAR (photograph E in Figure 3.8), which appeared to move downstream to GCP (Table 3.11), where there was then another dry-weather pipe discharge into the stream observed. To understand what was being discharged from the pipe, and to determine separate contaminant sources, samples of nutrients were taken from the GCP pipe and stream at WAR for comparison (Figure 3.10). From this, the pipe at GCP appears the source of elevated ammonia, whereas the hydrocarbon slick was sourced around WAR (higher concentrations there) and travelled downstream to GCP.

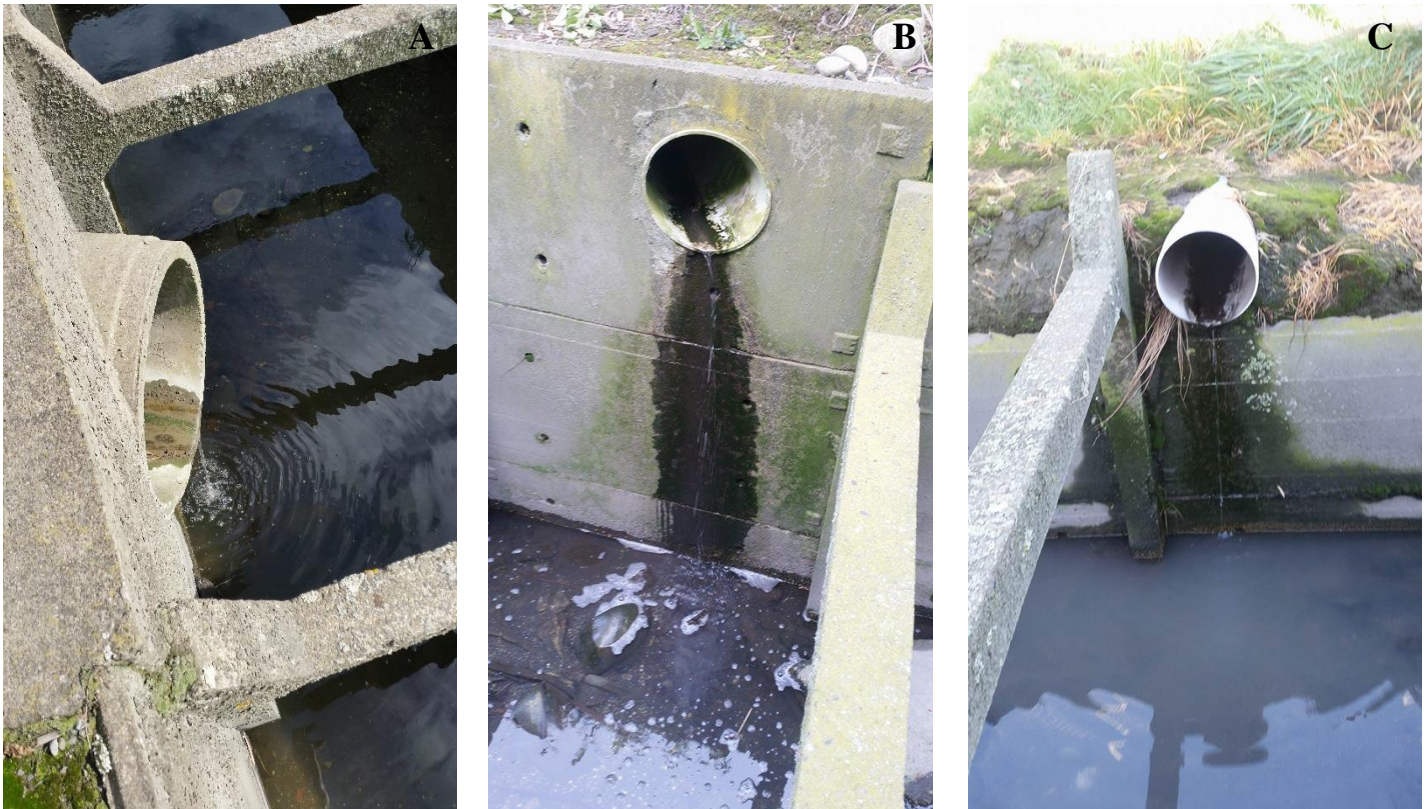
Figure 3.11 Pipes seen discharging downstream of Washbournes Road

Haytons Stream re-emerges from the stormwater network at Washbournes Road as a box-drain style waterway, flowing between industrial sites until its confluence with Paparua Stream. There are many stormwater pipes along the side of the stream at this site, three of which were observed discharging in dry weather (Figure 3.11), with two separate pipes sampled (one pipe sampled twice- three samples overall- Figure 3.12).

Of these photographs, pipe A was observed discharging on 23/3, 5/5 and 29/5 in dry weather, and was sampled on 5/5 and 29/5 to compare concentrations. The second pipe (B) was caught discharging on 8/9 and was sampled. Pipe C was seen on a sporadic visit where sampling equipment was not available, yet pictures and location were passed on to local authorities.

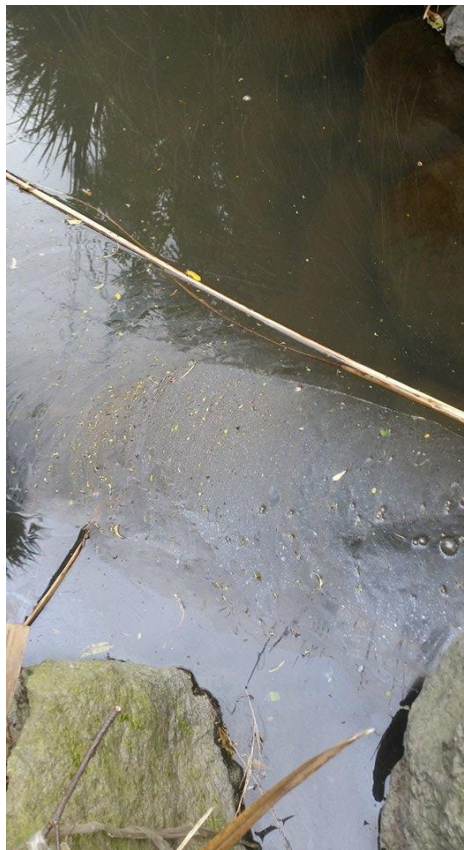
Figure 3.13 Sewage smelling scum at Gerald Connolly Place 27/9/17

On 27/9, upstream of the usual sampling point at Gerald Connolly Place, there was a large, shiny (glitter-like) scum on the stream surface that had a strong sewage smell (Figure 3.13). The scum was sampled, and contained low concentrations of nutrients, yet a high *E. coli* concentration of 517 MPN/100 ml (Table 3.9). This high *E. coli* during what was a dry weather (baseflow) condition does appear to suggest a form of sewage or organic material pollution near this site, especially considering the maximum baseflow *E. coli* concentration at WAR (a few hundred metres upstream), was 61 MPN/100 ml over three separate baseflow runs.

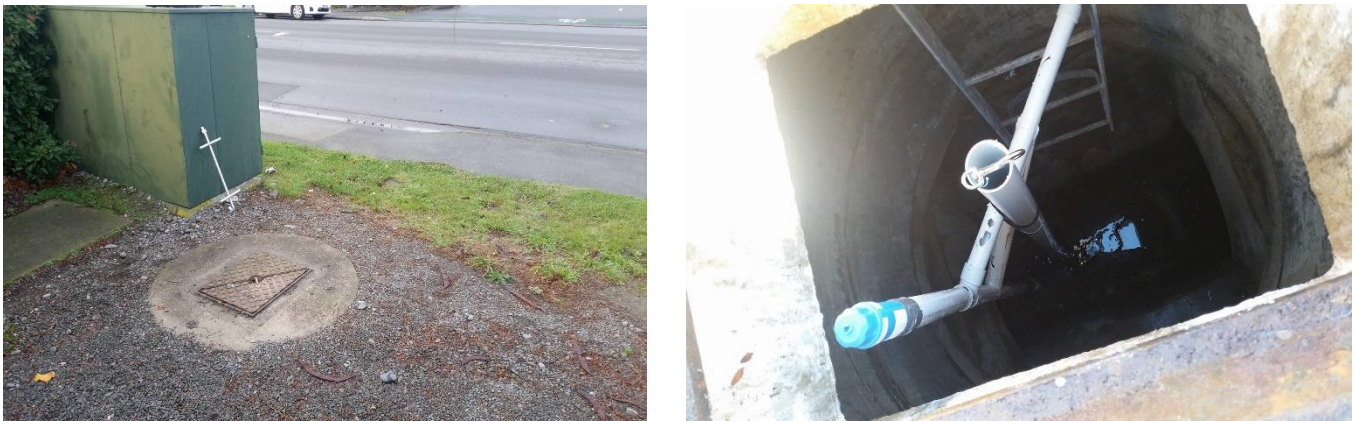
The first loggers in the catchment were placed down a network manhole on Waterloo Road (-43.538192, 172.533743). Loggers were upheld and supported by PVC pipe structures (Figure 4.1) within the pipe infrastructure, allowing the loggers to record in the middle of the manhole, as well as an easy access to the logger's data ports without the need to enter the manhole.

Figure 4.1 Manhole on Waterloo Road with loggers upheld with PVC structures

As there were very frequent fluctuations in water level passing through the manhole on Waterloo Road, the upper catchment loggers were plotted together to distinguish if this was the source of the continual fluctuations observed in Haytons Stream at Waterloo Road. However as can be seen from Figures 4.20 and 4.21 below, the frequency of fluctuations passing through the manhole on Waterloo Road (recorded by the logger) are much greater and are of a much lower magnitude (size) than those recorded by the logger in Haytons Stream. Additionally, the fluctuations recorded in Haytons Stream at Waterloo Road appear to be of a greater volume (rising the water level to a greater extent). This indicates that although water passing through the manhole on Waterloo Road is likely contributing to some of the regular fluctuations seen in Haytons Stream, there must be other frequent dry weather inputs via the stormwater network occurring along Waterloo Road, either above or below the logged manhole.

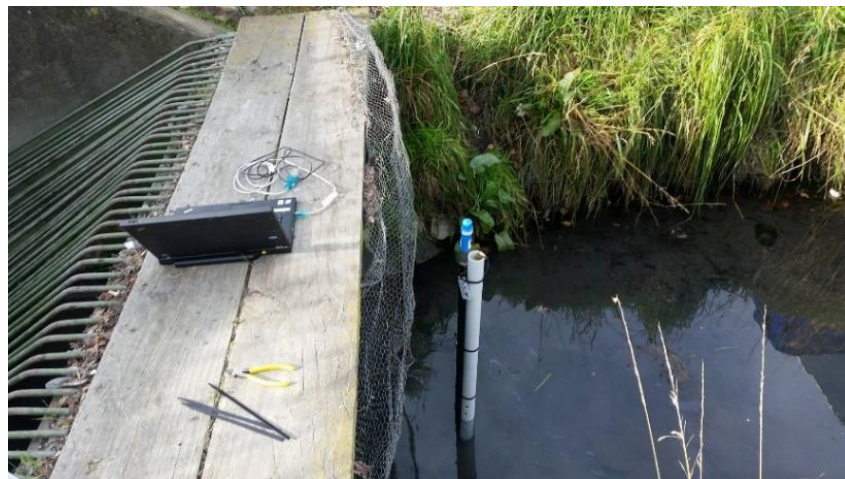
This logger set (Figure 4.2) was installed at the first point of open-channel flow on Haytons Stream (-43.537606, 172.541844), to log whatever is immediately exiting the stormwater drainage system from the upper catchment.

Figure 4.2 Logger set at Haytons Stream on Waterloo Road

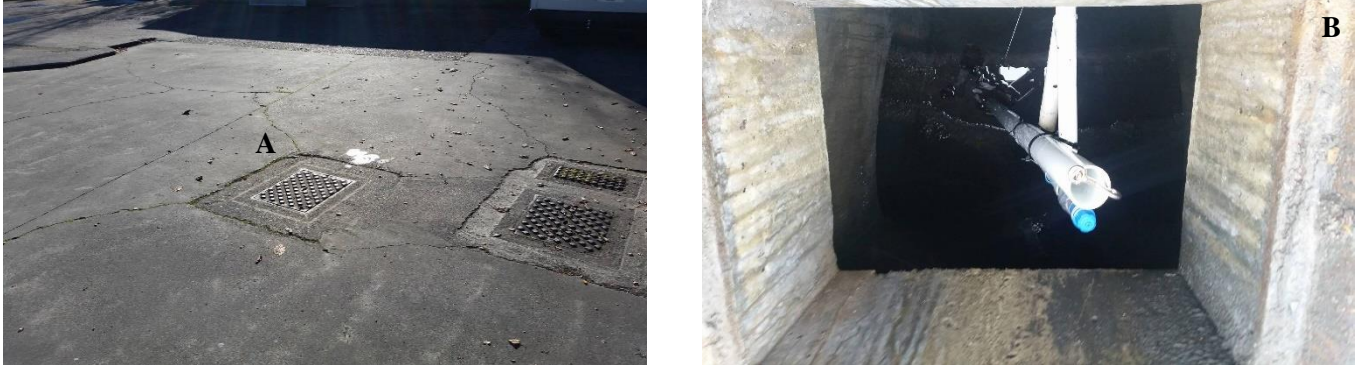
These loggers were placed down a large stormwater pipe (A) located in the Versatile car park off Springs Road (-43.544191, 172.545827). Photograph B shows inside the infrastructure (Figure 4.3).

Figure 4.3 Springs Road manhole and view of loggers inside

Logging in the lower catchment (Figure 4.22; of Springs Road manhole, Washbournes Road and Wigram Road) gave similar indications to discharge sources. When comparing the Springs Road manhole to Haytons Stream at Washbournes Road, there are clear water level fluctuations occurring at WBR which are not recorded in the manhole. For the short time Wigram Road was logged, the observed fluctuations at WBR were also not recorded further downstream, indicating that discharges are occurring and sourced from industry at or very close to Washbournes Road. Field visits and site sampling verify this hypothesis, where visible pipe discharges were observed along the box-drain walls of Haytons Stream at Washbournes Road (discussed in Chapter Three). This also indicates that as far as this study has found, no dry weather inputs of appreciable size were recorded in the manhole off Springs Road, suggesting that the dry-weather inputs observed at Washbournes Road were sourced much closer to Haytons Stream in the nearby stormwater network.

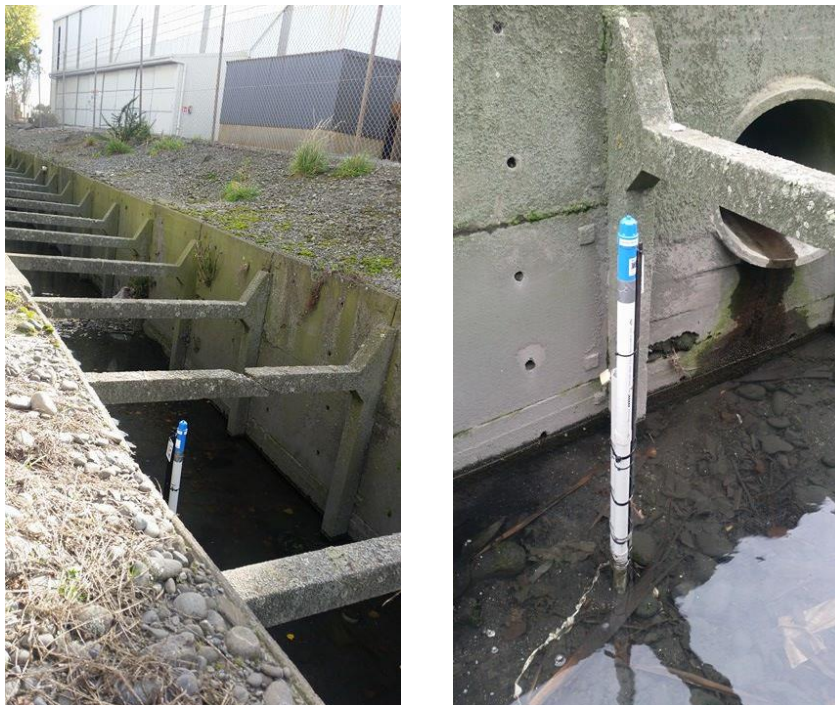
Figure 4.4 Logger set downstream of Washbournes Road

The third logger set was placed downstream of the sampling site at Washbournes Road (-43.543984, 172.554321), and below a stormwater pipe that was found discharging during dry weather several times during site visits (WBR pipe discussed in chapter three) (Figure 4.4).

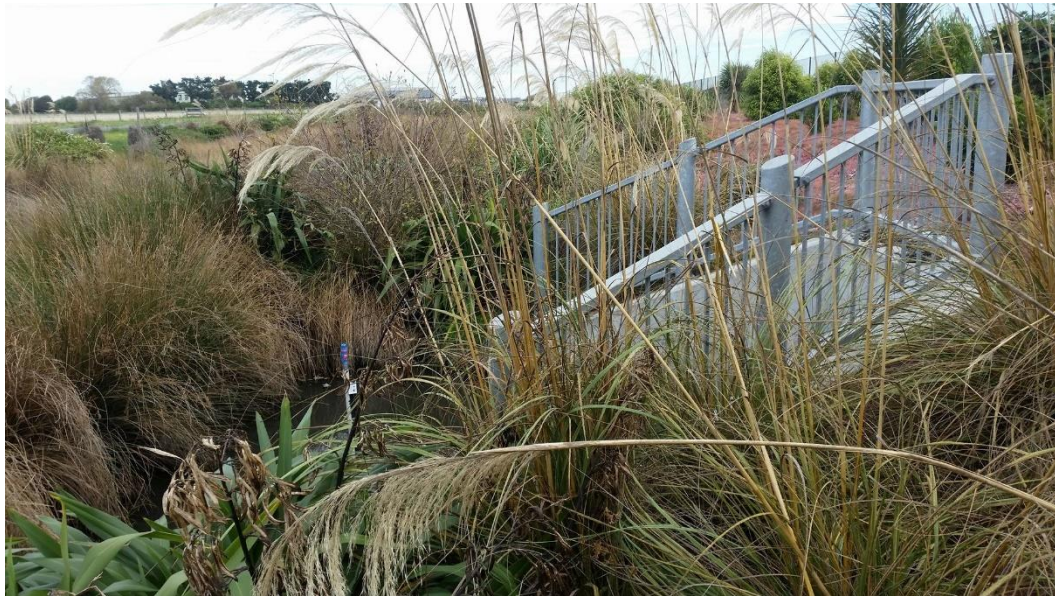
The fifth set of loggers were placed in a stormwater ‘pool’ area immediately upstream of Wigram Road (-43.552845, 172.567658), which were logging immediately below a large stormwater pipe draining new industrial sections in Wigram (Figure 4.5).

Figure 4.5 Logger set downstream of stormwater pipe above Wigram Road

After seven weeks of logging water level (28/4 – 16/6) and three weeks logging conductivity (19/5 – 9/6) it was concluded that the logger location by Wigram Road was not collecting insightful data to determine the occurrence of any dry weather/ point-source discharges at this location (see results section). The logger set was subsequently moved to Haytons Stream at Gerald Connolly Place (-43.540274, 172.543021) to facilitate more intensive monitoring in the industrial upper catchment, and generate comparable data with O’Sullivan and Charters’ (2013) continuous logging at this location.

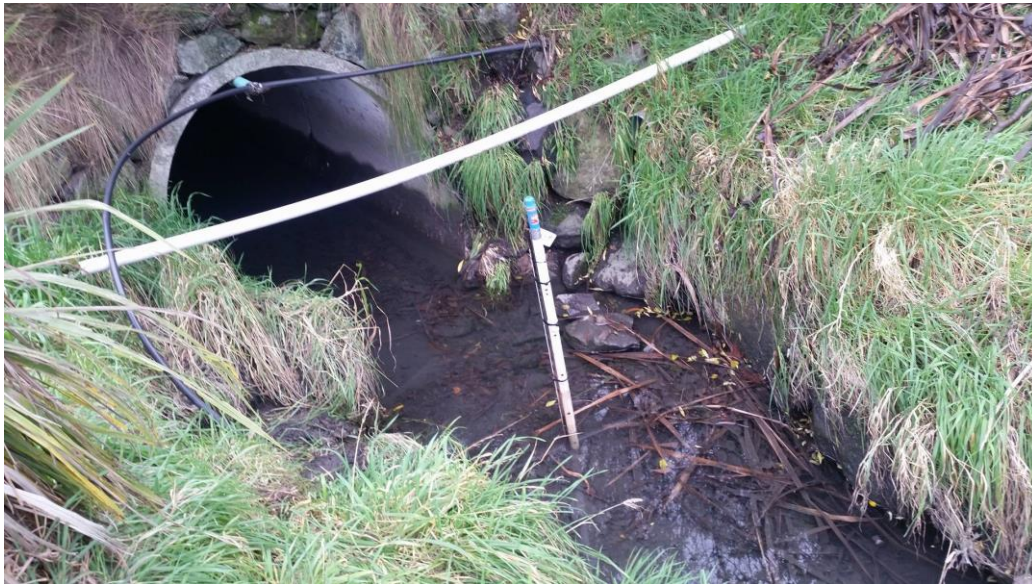
Loggers were installed at Gerald Connolly Place on 16/6/17, which were placed immediately after the exit of the stream from an underground culvert at the end of the cul-de-sac on Gerald Connolly Place (Figure 4.6).

Figure 4.6 Loggers at Gerald Connolly Place

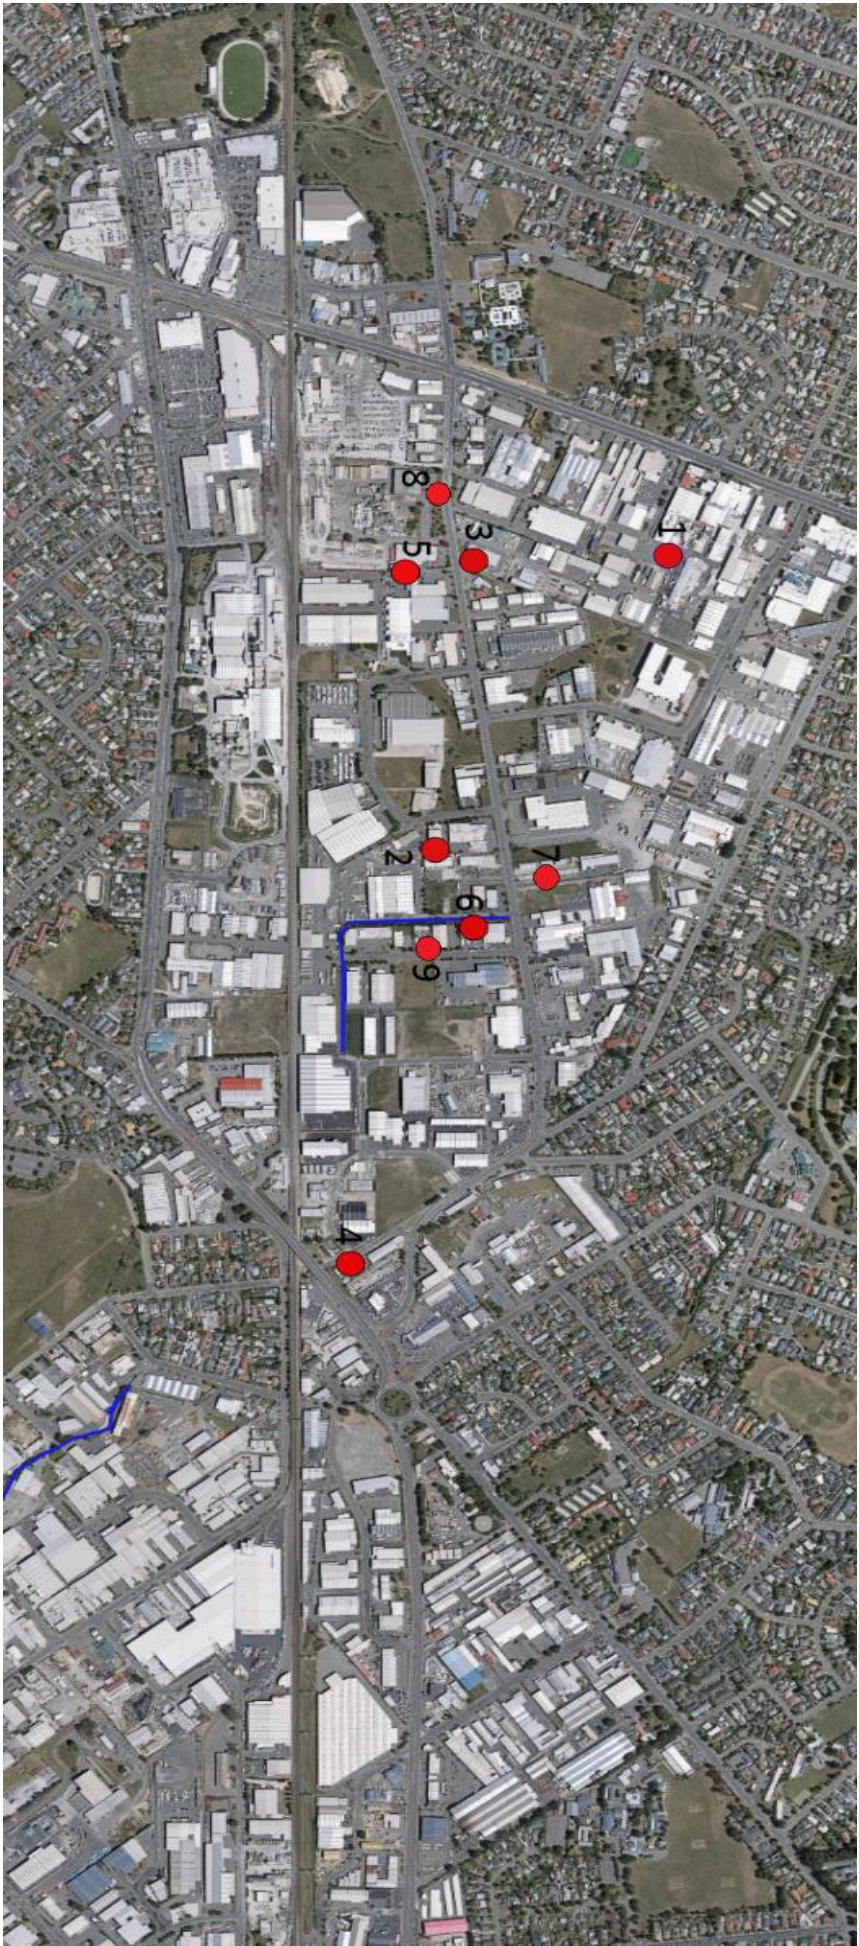
The locations of the nine sampled sumps in the Haytons Stream catchment is presented in Figure 4.7, and each sump is described below (Table 4.1). Potential sampling locations were agreed and planned in conjunction with Environment Canterbury and Christchurch City Council staff, utilising their knowledge of industry and historical pollution in the catchment to create a list of sites that were viewed as ‘risky’ for contamination, or having potential to contribute pollutants to Haytons Stream via the stormwater network. Sumps were photographed when sampled (Figure 4.8).

Figure 4.7 Sump locations in Haytons catchment (stream in blue) Edited from Google Maps (2017)

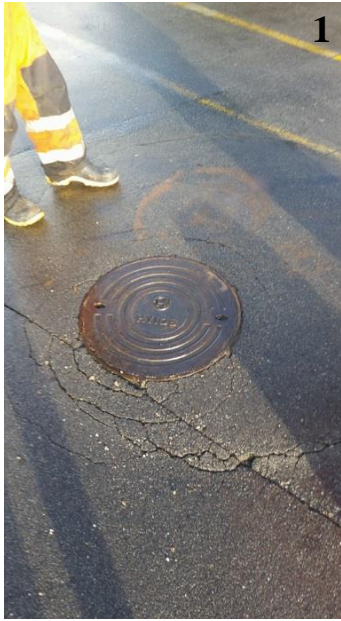
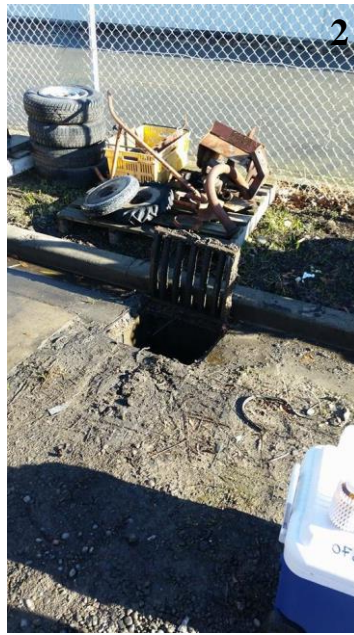
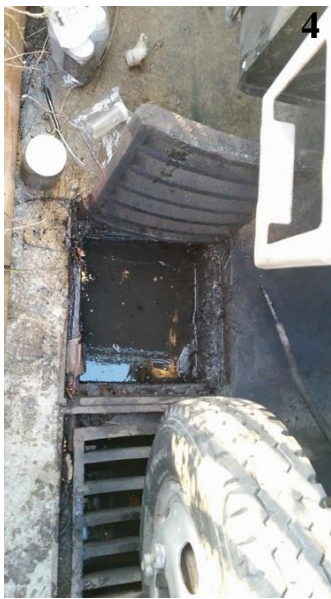
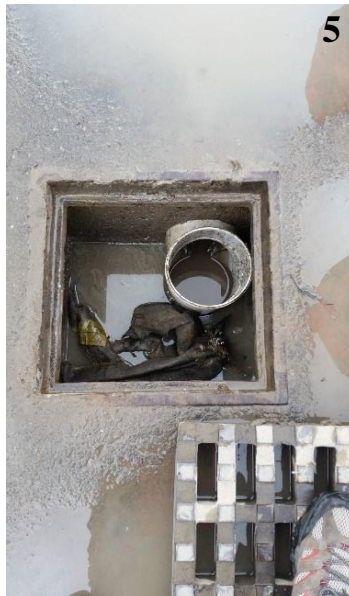
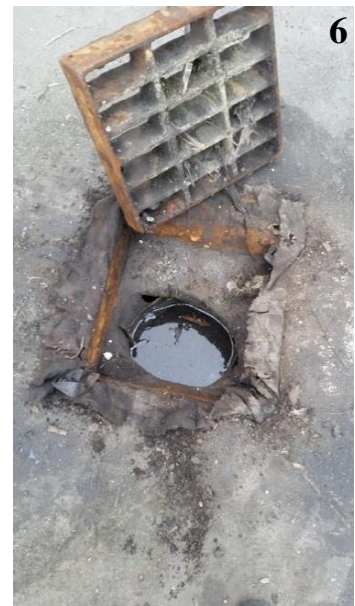
Figure 4.8 Appearance of sampled sumps on the given day (sump numbers displayed). Refer to Table 4.1 for site description

Sump number	Industry character
1	Animal material processing
2	Hydraulic servicing
3	Sanitary equipment cleaning
4	Truck parts/repairs
5	Excavator/van depot
6	Bus repairs
7	Machinery repairs
8	Chemical manufacturing
9	Panel beating/car repairs
